Manhole Inspection Summary

Manhole # S63A1_005MH

Inspection ☐ Is Incomplete Rating: **3) Fair**

Location Address: **2220 Vail St.**

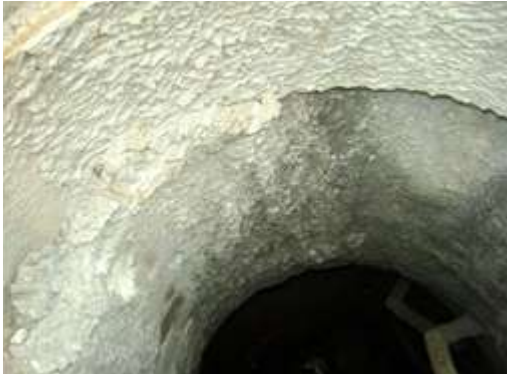
Defect 2

Condition: ☐ Sound ☐ Cracked ☐ Root Intrusion ☐ Loose Brick ☒ **Deteriorated**

deterioration

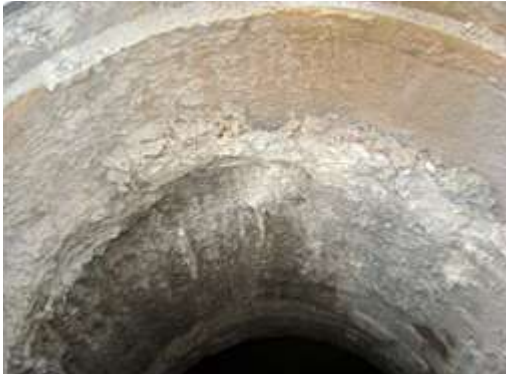
Defect 1

Comments **ENTIRE CHANNEL IS CLOGGED WITH DEBRIS AND THERE ARE MANY SOURCES OF INFILTRATION PRESENT, SEE PICTURES.**

infiltration

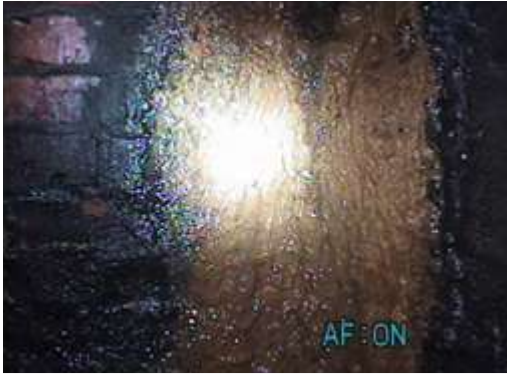
Defect 4

Infiltration: ☐ None ☒ **Joint** ☒ **Cracks** ☐ Mortar ☐ Roots ☒ **Wall**

on barrel wall

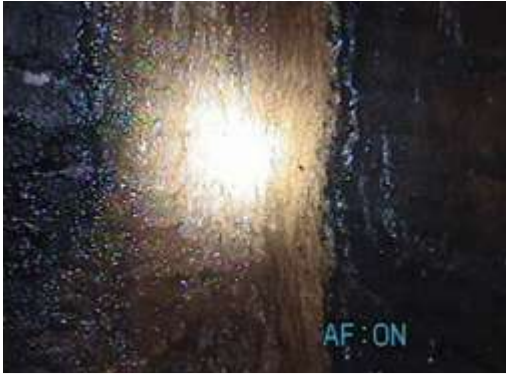
Defect 3

infiltration on barrel wall

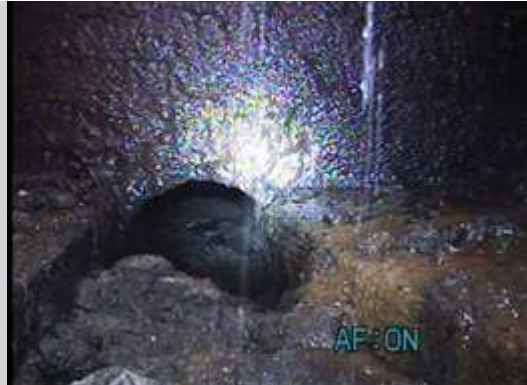
12 O'Clock Outflow

Pipe Height: **8.4** (in.) Rod and Bar (Angled)
Pipe Material: **Clay** ☐ Pipe Lined
Invert Depth: **13.08** (ft.) Flow Characteristics: **Slow**
Deposits: ☐ None ☐ Mud ☐ Sludge ☒ **Debris** ☐ Grease
Silt Depth: **8** (in.) Deposits Extent: **Heavy**
Infiltration: **None** Pipe Seal Cond: **Sound**

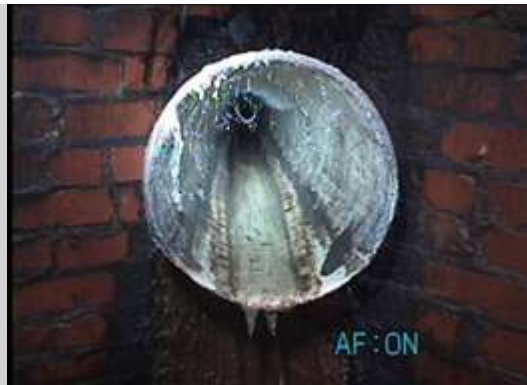
5 O'Clock Inflow

Pipe Height: **8.4** (in.) Rod and Bar (Angled)
Pipe Material: **PVC** ☐ Pipe Lined
Invert Depth: **8.83** (ft.) Flow Characteristics: **None**
Deposits: ☒ None ☐ Mud ☐ Sludge ☐ Debris ☐ Grease
Silt Depth: (in.) Deposits Extent:
Infiltration: **None** Pipe Seal Cond: **Sound**

☒ Possible Illicit Connection
